The fire extinguisher installation of the L-39

Some theoretical aspects why to use the OEM equipment as it was designed by Aero Vodochody and some concerns about changing the OEM fire extinguisher equipment against other products.

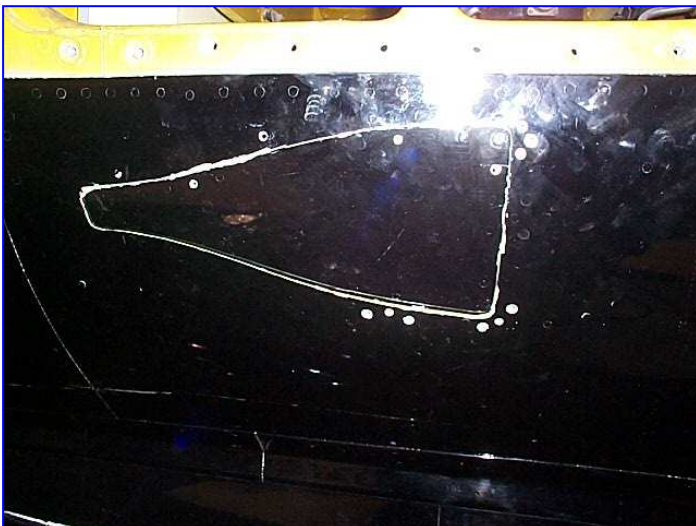
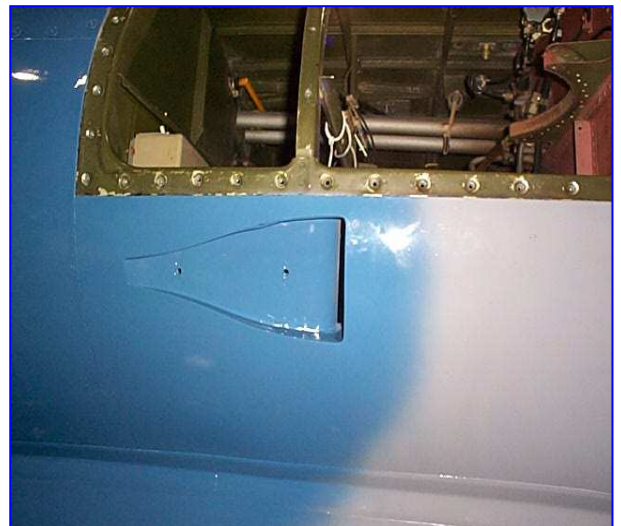
D) Closing your NACA inlets, to make the airplane more aerodynamically, is also a bad idea. The cooling air is missing at all and beside of the fire problem, you will burn your hydraulic pump, due to the increasing temperature of the hydraulic fluid in the tank. At a temperature $> 85^{\circ}\text{C}$, your pump will start with cavitations on the suction side.

We have seen it, even in the cold of Alaska!

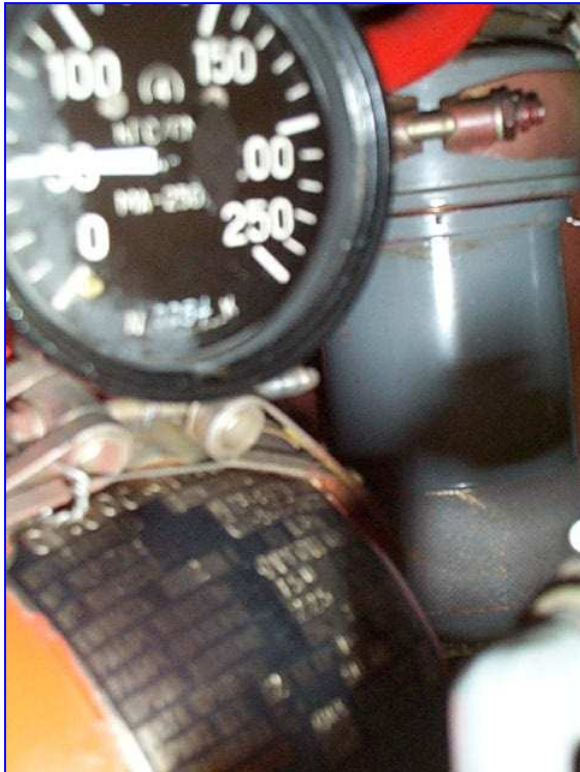
Just 50 kP/cm² (Freon 114 V2)

(Both bottles found installed in US airplanes.)

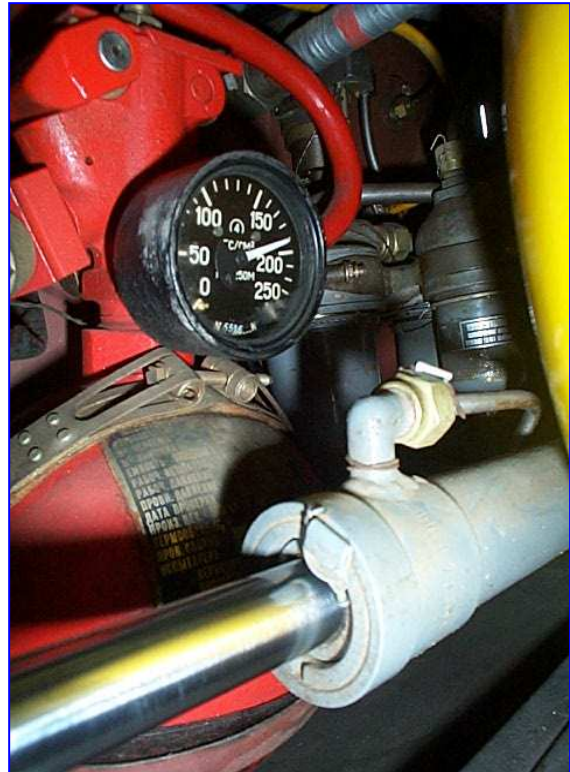
Impressive 190 kP/cm² (Mixture 7)

A bottle showing 190 Kp/cm² on its gauge (like above on the right) may discharge (explode) at any given moment (without asking you).

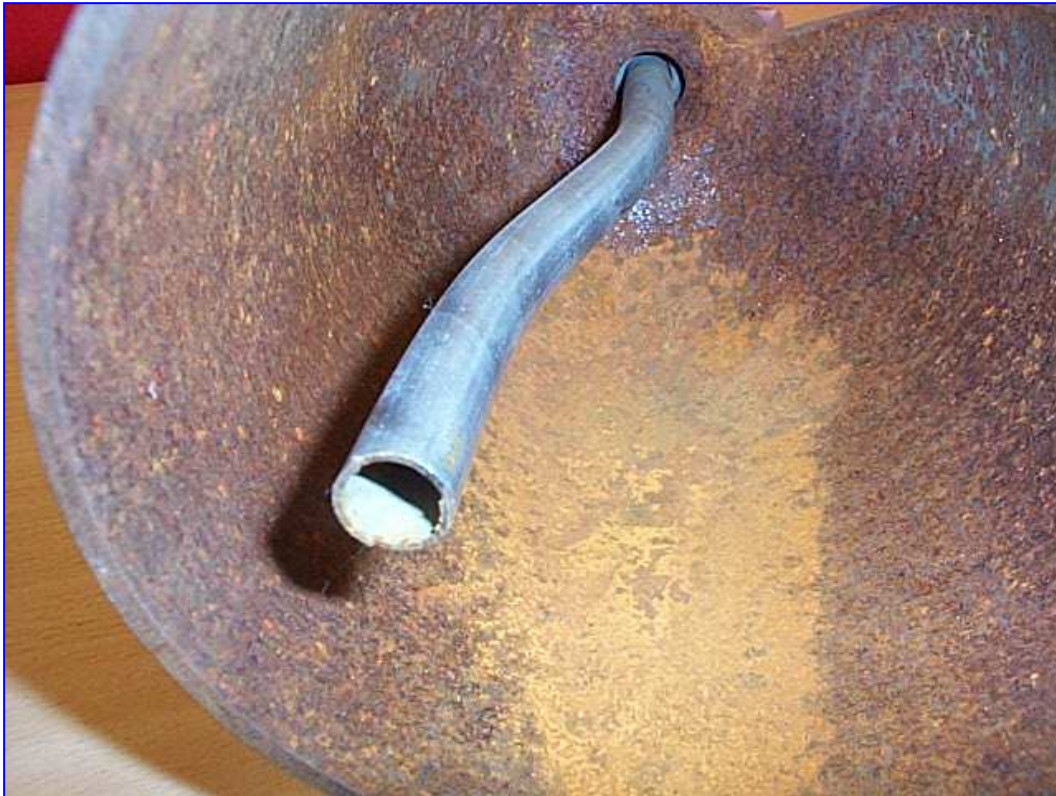
The bottle may look inside like this:

This is the influence of the old extinguishing medium on the bottle's steel wall over the years. If bottles are evacuated incompletely during the last overhaul or refilled with incorrect technology, where air can get into the bottle, a chemical reaction will start. It's just a matter of time until something goes really wrong.

The rusty fire bottle above didn't have a chance for a 2nd or 3rd life....

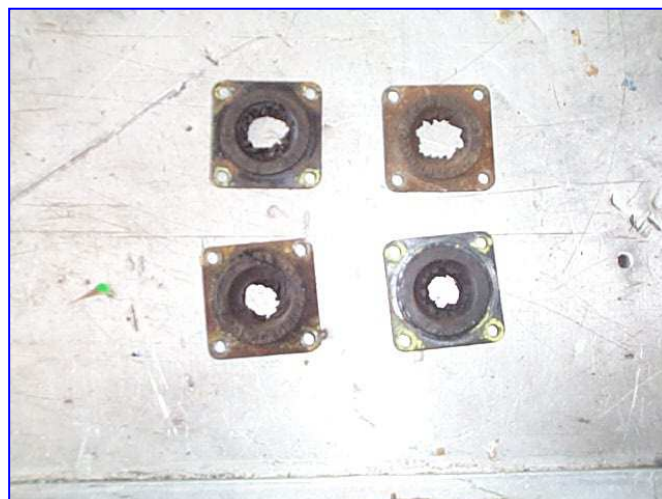
---but you need to push the box up to see the real condition of the rubber mounts. They may look like this:

Please note that a correct installation of the BI-2I electronic box in the RAT well is necessary. The box must be mounted on 4 perfectly working shock mounts. The shock mounts absorb the touch down shock during landing. Any hard touch down with insufficient shock mounts is like poison for the polarized relays inside!

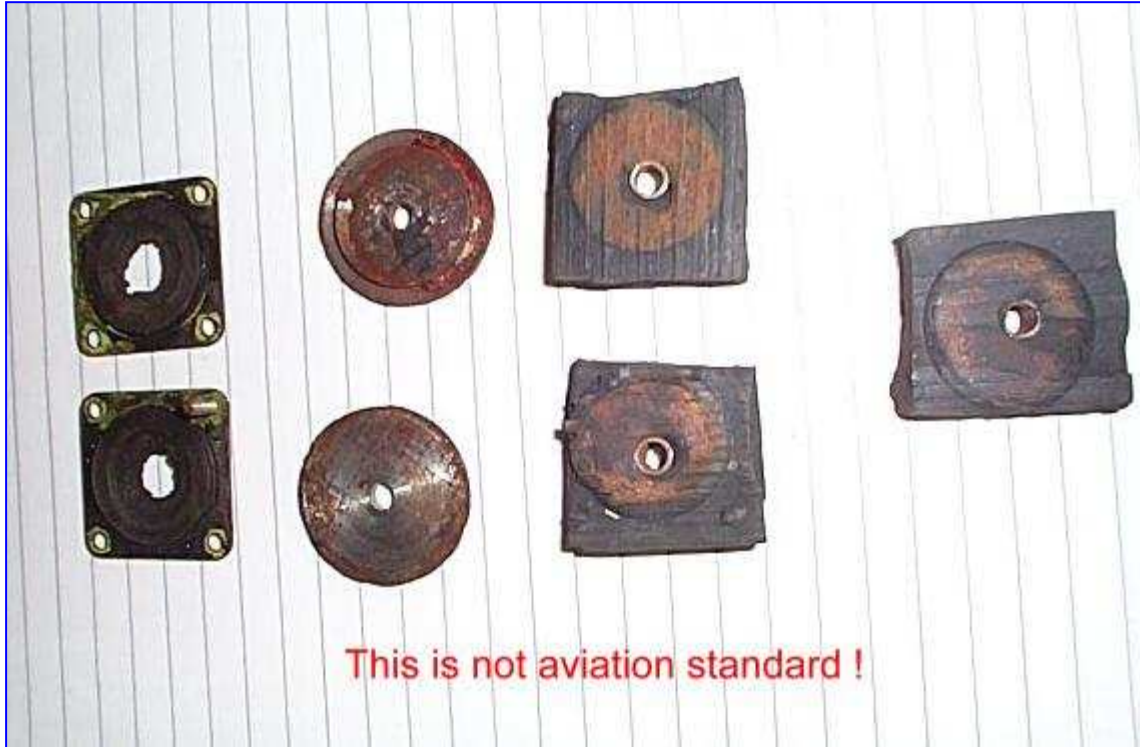
We have also found some very special things like BI-2I boxes strapped to the console with tie-wraps or lock wire, or even “hard mounted” with steel washers.

This is not aviation standard !
