The fire extinguisher installation of the L-39

Some theoretical aspects why to use the OEM equipment as it was designed by Aero Vodochody and some concerns about changing the OEM fire extinguisher equipment against other products.

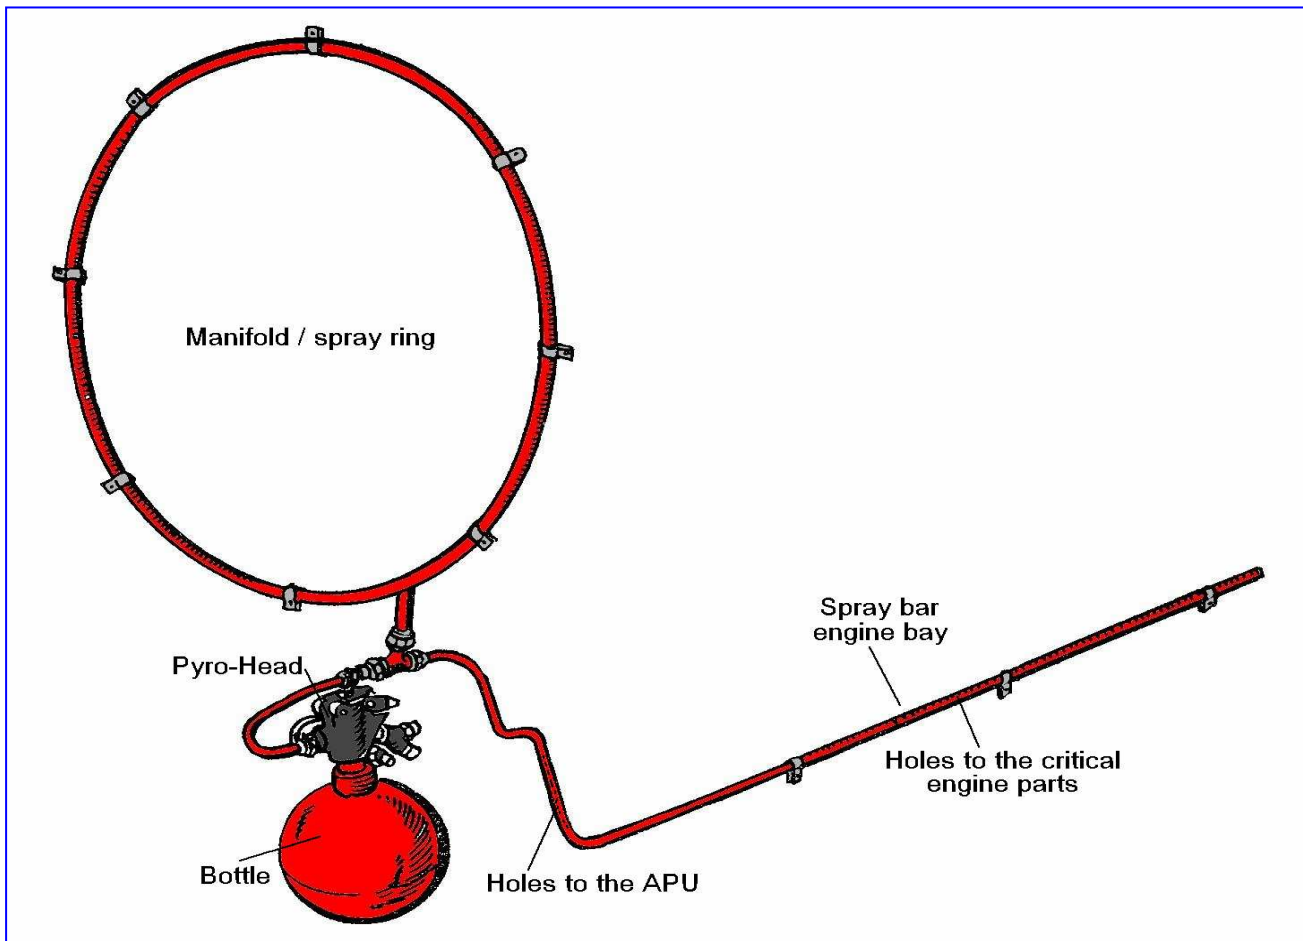
The efficiency of the complete fire extinguishing system of the L39 was verified during the development tests in 1971. A real fire was set inside the engine bay with the engine installed. The center of the fire was supplied with a stream of fuel in the quantity equal to maximum engine fuel consumption. The initial time of burning the injected fuel

was 22 seconds. After that the fire was extinguished by the onboard fire extinguishing system. The measured temperature in the engine bay reached 800°C. The fire didn't move forward into the bulkhead 29-32 area.

The layout of the spray assembling has been made in that kind, that with the number of little bores which are intentionally located in special areas of the spray system in direction to the critical items in the engine bay, a high efficiency is reached. The number of bores in the spray assembly allows a certain extinguishing medium “flow”, over a defined period, to extinguish a fire. For this reason the DTBG fire sensors have been also located in the engine bay in areas where fire may occur.

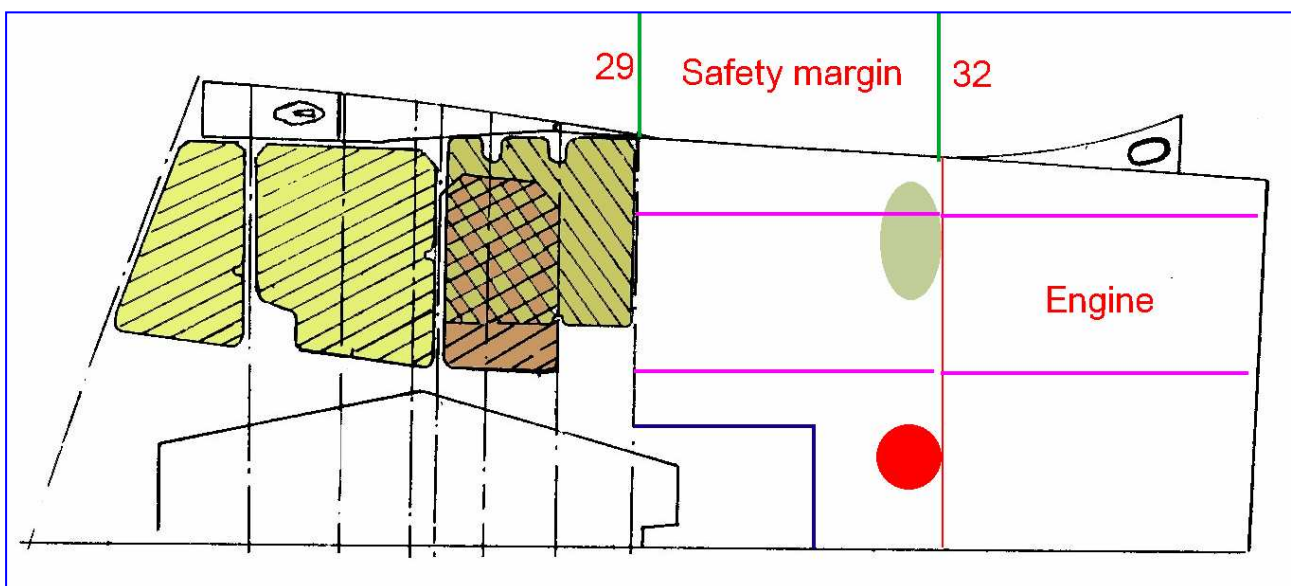
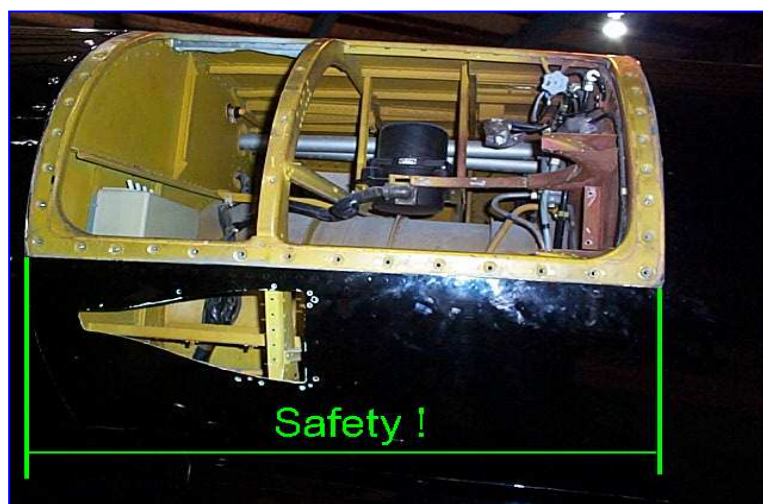
The space between bulkhead 29 (rear part of the fuel tank installation) and bulkhead 32 is also known as "RAT well", and is your safety margin between the engine and the fuel cells.

So any installation of auxiliary fuel tanks or smoke oil tanks, in the size/volume exceeding the former radio equipment installed in this section:

A) Disturbs the cooling air flow and reduces the amount of air going through the blast hole around the engine inlet.

B) Your safety margin (fire protection between engine compartment and fuel tanks) is almost ZERO!

C) In case of a fire propagation forward of the bulkhead No. 32, the overheating of the extinguishing bottle evokes an increase of the extinguishing medium pressure. When the bottle temperature is above approx. 160°C, the safety valve is initiated and the extinguishing medium is spread into the area between bulkheads No. 29-32. The extinguishing medium expansion causes the absorbing or extinguishing of the fire.

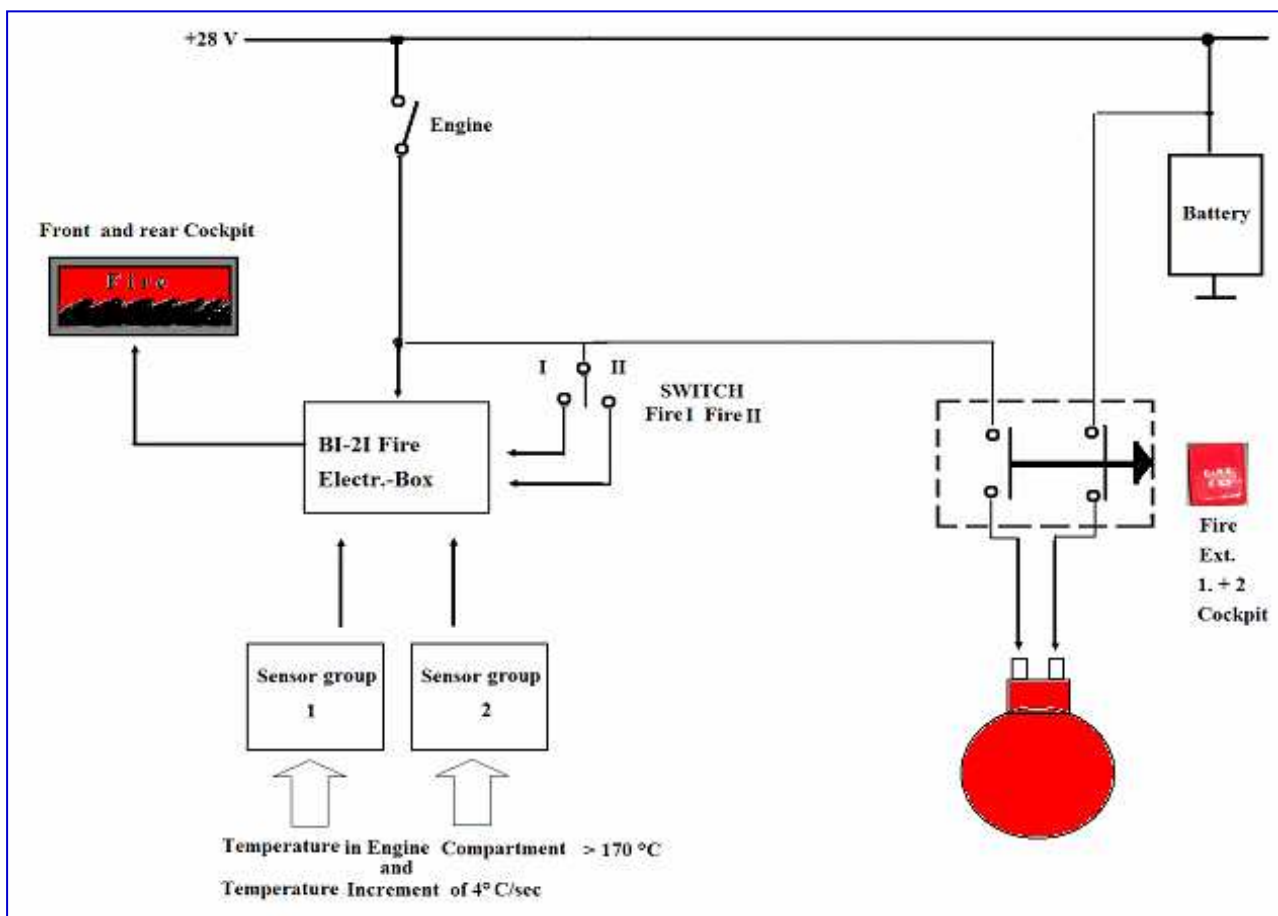
3) The fire detecting system of the L-39

The detecting system mainly consists of the BI-2I electronic box in the RAT well, the two groups of sensors (3 each) and the fire extinguisher bottle.

The system can be activated by two push buttons in the front and rear cockpit. The electrical power supply is provided in two ways, from the electrical board network (main) and direct from the battery (back up). Both are simultaneously activated for safety reasons.

Note: The fire test switch Fire I and Fire II conducts only the test of the sensor groups to ensure that all sensors are in a closed loop and are not interrupted.

The activation threshold of the electronic box (Temperature of 170°C in the engine compartment with a temperature increment of 4°C per sec) can only be tested with a special tester.

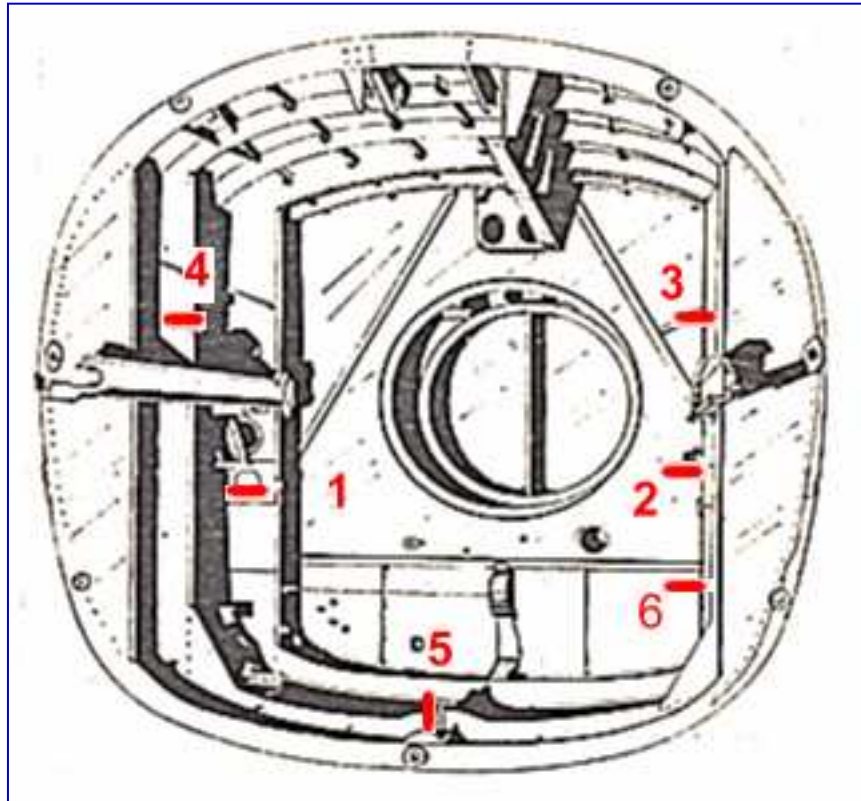
The sensors are located on the most dangerous places in the engine compartment!

| 1) APU | 4) L/H Igniter |
| 2) Generator | 5) Waste can/FCU |
| 3) R/H Igniter | 6) Air-Starter/FCU |

Attention: The last 3 engine fires (hereof one in flight/in France) have not been recognized by the pilot due to the inop fire detecting system.

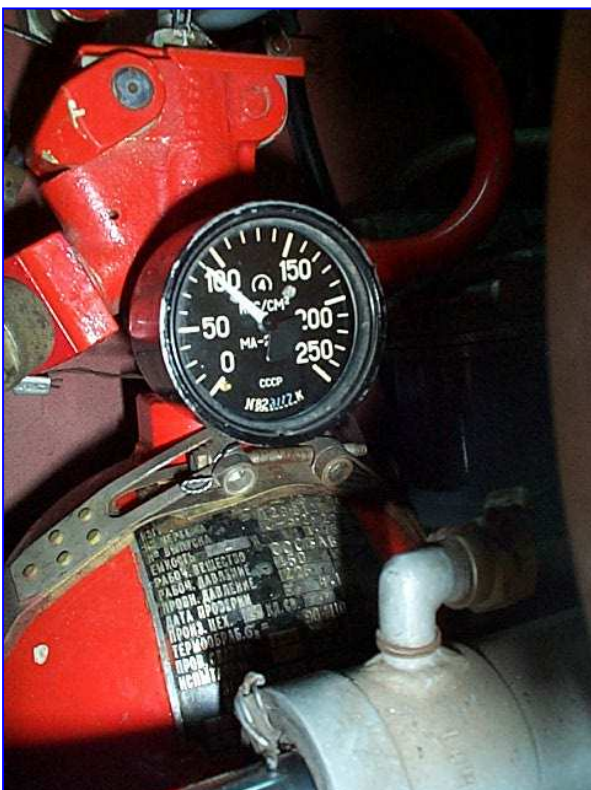
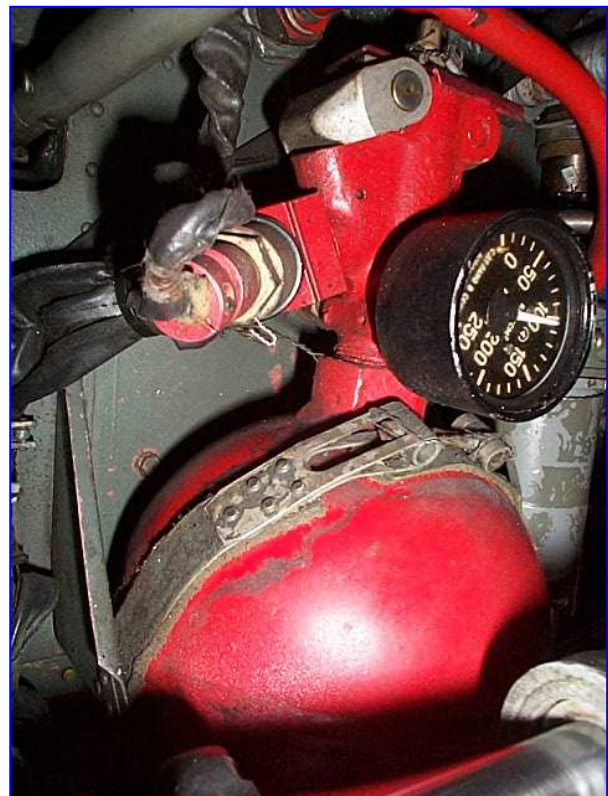
It’s assumed that some of the bottles are far over their life time limit but show still some pressure. If the gauge shows something around 90 - 110 kp/cm², it looks okay, depending on the temperature and on the first glance.....

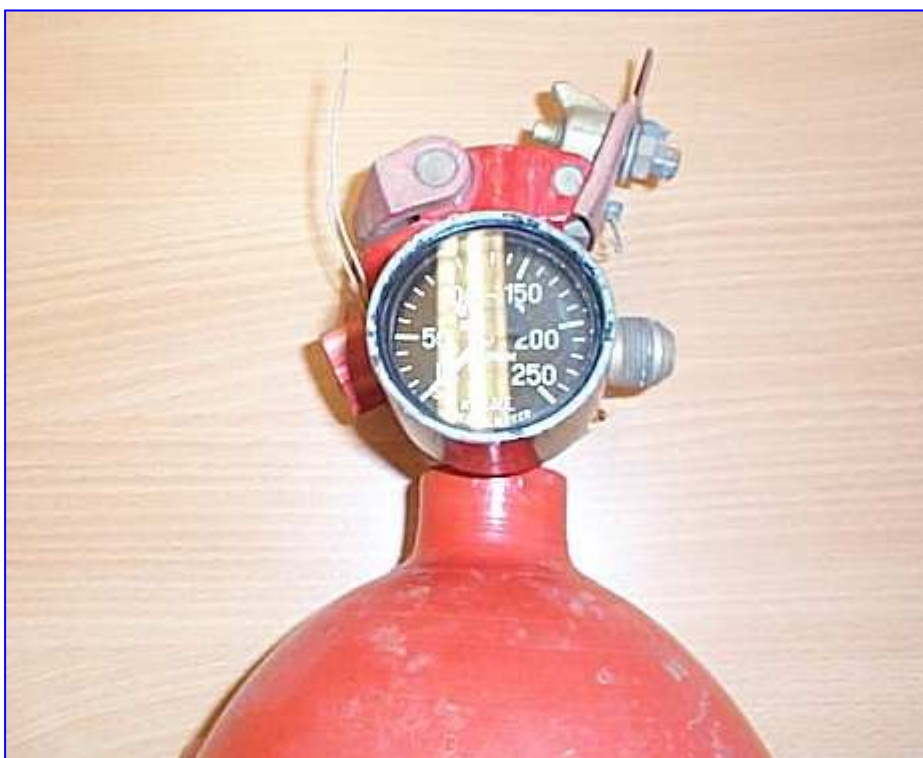
However, sometimes the inner life of a fire bottle looks not too impressive!

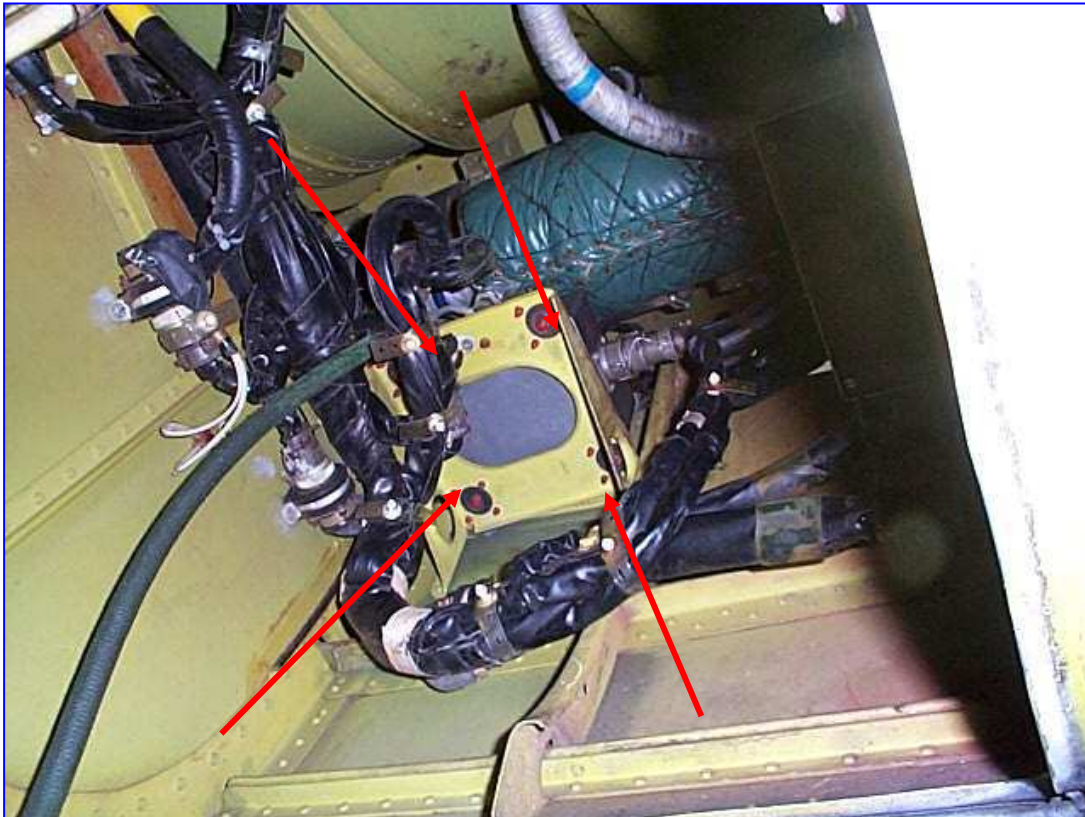
Please note that a correct installation of the BI-2I electronic box in the RAT well is necessary. The box must be mounted on 4 perfectly working shock mounts. The shock mounts absorb the touch down shock during landing. Any hard touch down with insufficient shock mounts is like poison for the polarized relays inside!

From the distance it may look OK.....

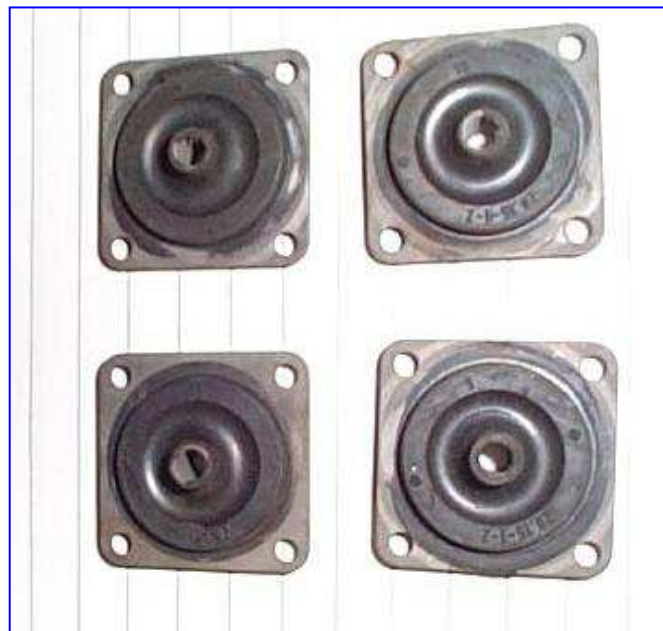
New ones look like this:
